**CALIFORNIA REGIONAL WATER QUALITY CONTROL BOARD - SAN DIEGO REGION  
WATERSHED MANAGEMENT PROGRAM**

**FACILITY INSPECTION REPORT**

**Sprinter Rail Project**

FACILITY: North County Transit District Sprinter Rail (WDID) 9 37C322900 INSPECTION DATE: 11/27/07

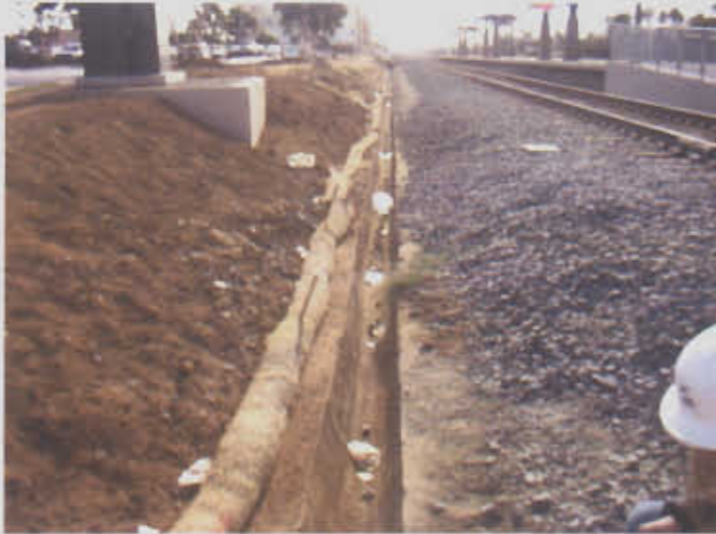
1. Drainage ditch with a significant amount of trash and sediment. No erosion controls on slope.

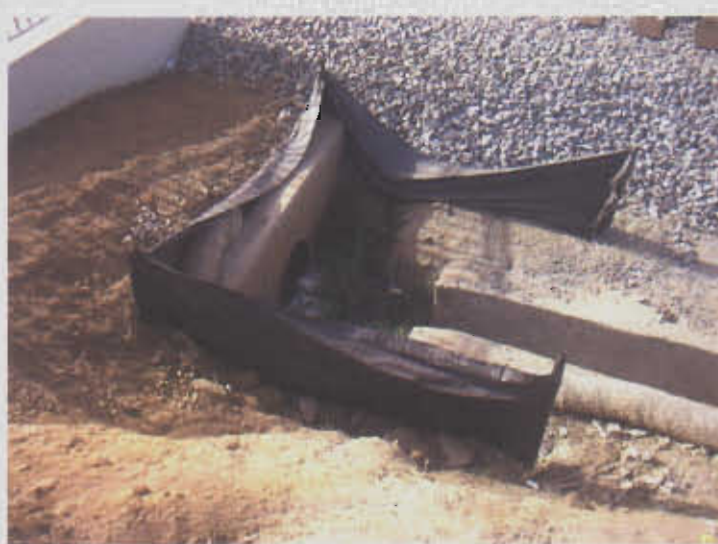
2. Silt fence in need of maintenance.

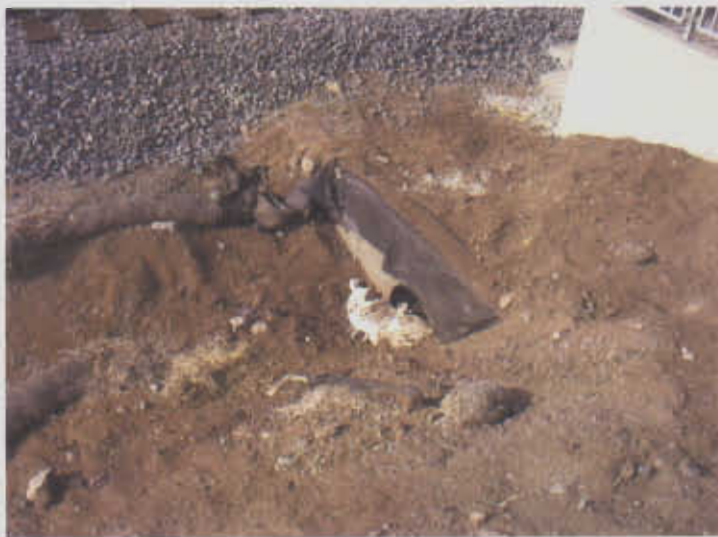
3. Silt fence not properly maintained, fiber roll dislodged into drainage ditch and insufficient inlet protection. Earthen channel needs stabilization.

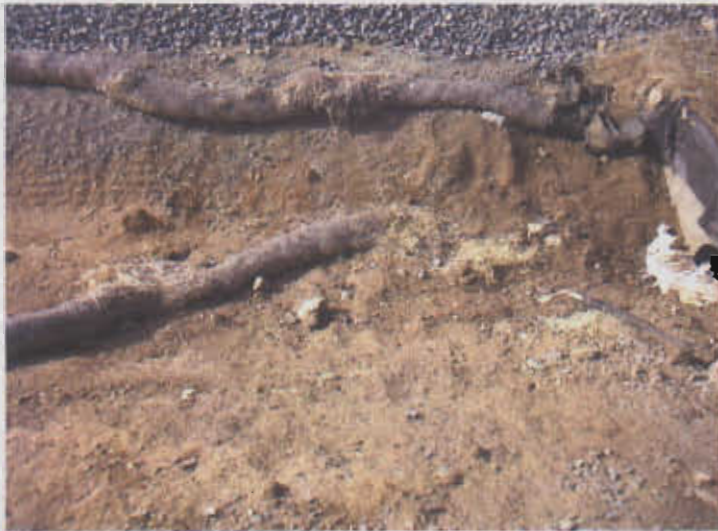
4. Fiber rolls on slopes out of place due to not being adequately staked in and trenched in.

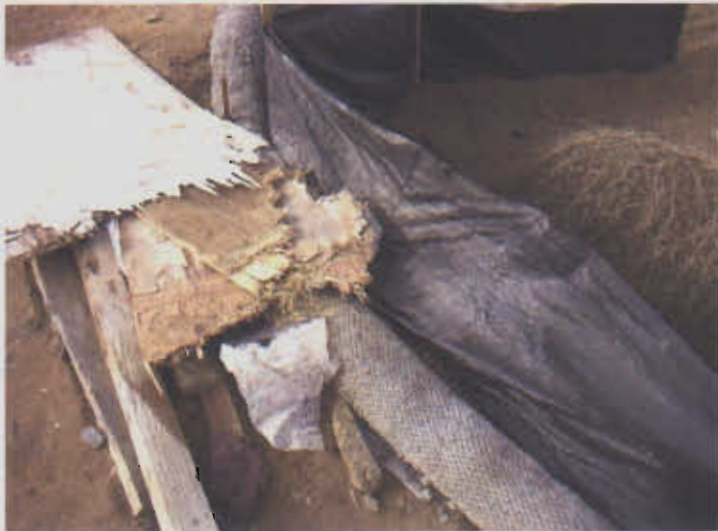
5. Silt fence flattened by construction debris above head wall of storm drain inlet.

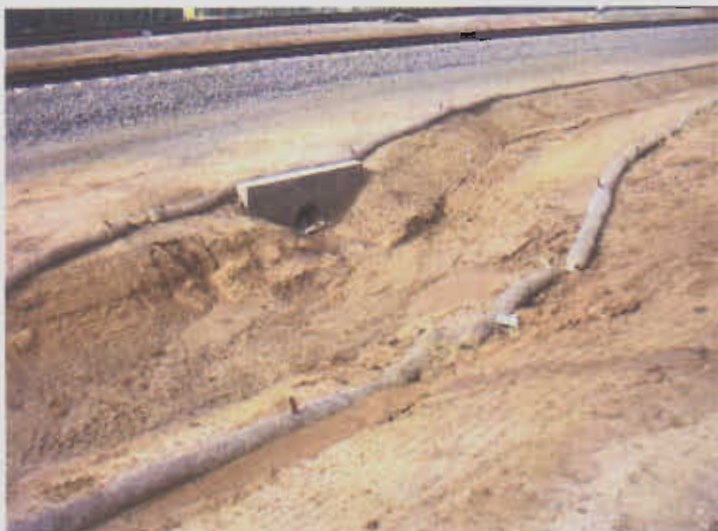
6. No erosion controls on slopes. Inadequate inlet protection. Fiber rolls not trenched in. Dirt channel needs protection.

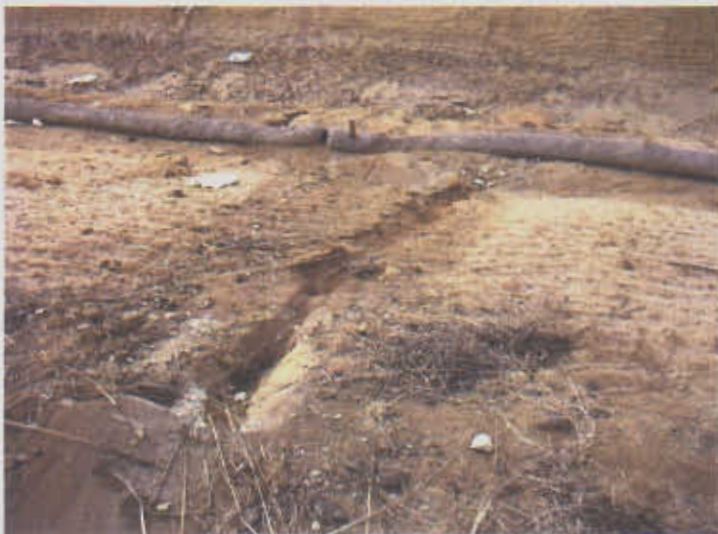
**1. Oceanside Transit Center in Oceanside** - The Sprinter tracks are southwest of a transit station that is already being used by the Coaster, Amtrak and Metrolink. This station is near the corner of Tremont Street and Seagaze Drive. A long stretch of west-facing slope was without erosion controls – only fiber roll at the toe of the slope. In addition, there was a significant amount of trash and sediment in a concrete-lined ditch below the slope (Photo 1). The ditch led to a storm drain inlet with a silt fence that was in disrepair (Photo 2). Further to the south, a similar silt fence that was being used for inlet protection was completely collapsed (Photo 3). Also, fiber rolls had fallen into the ditch at this location and gravel bags outside the inlet provided inadequate inlet protection. The channel here consists of bare dirt which will result in sediment loads in the storm drain system during rainfall. Further along this channel, additional fiber rolls were observed to be dislodged into the earthen channel (Photo 4). Near another drain inlet, a silt fence had been knocked down by construction trash (Photo 5). Lack of stabilization of the earthen channel, improperly installed fiber rolls and inadequate inlet protection was evident at another location between the Oceanside Transit Center and Wisconsin Street (Photo 6). Failing or inadequately installed fiber rolls and lack of stabilization of bare soil was evident along this entire stretch of tracks (Photos 7, 8 and 9).

8. Gully formed below a storm water outfall – no erosion controls.

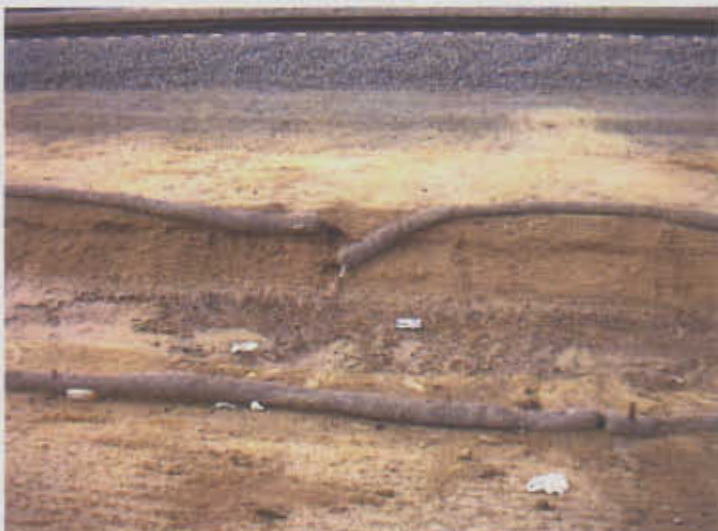
9. Fiber roll not properly staked in.

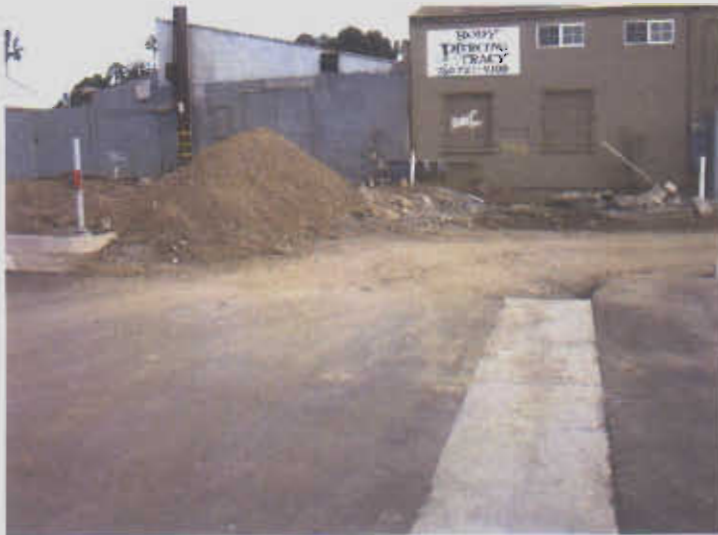
**2. Coast Highway Station in Oceanside** - This station construction is southwest of the intersection of Coast Highway and Godfrey Street. Sediment tracking BMPs were lacking in a dirt field next to the parking lot and there were no source or sediment controls for a stockpile of soil (Photo 10). A storm drain inlet in the station lacked any protection even though sediment was present in the area of the drain (Photo 11). Unstabilized slopes and inadequate inlet protection were also evident at this station (Photo 12) including an expansive, unprotected west-facing slope above another unstabilized earthen channel (Photo 13).

10. Sediment tracking on pavement and soil stockpile without erosion and sediment controls.

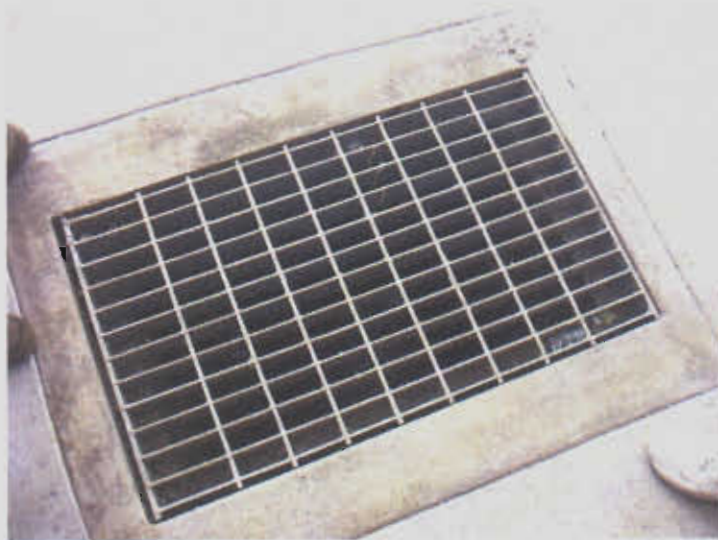
11. Storm drain inlet lacking inlet protection.

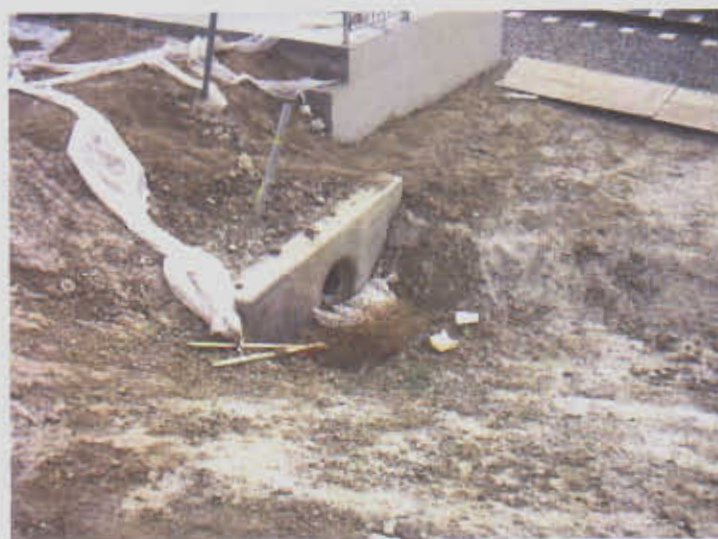
12. Inadequate inlet protection in an area with unstabilized slopes.

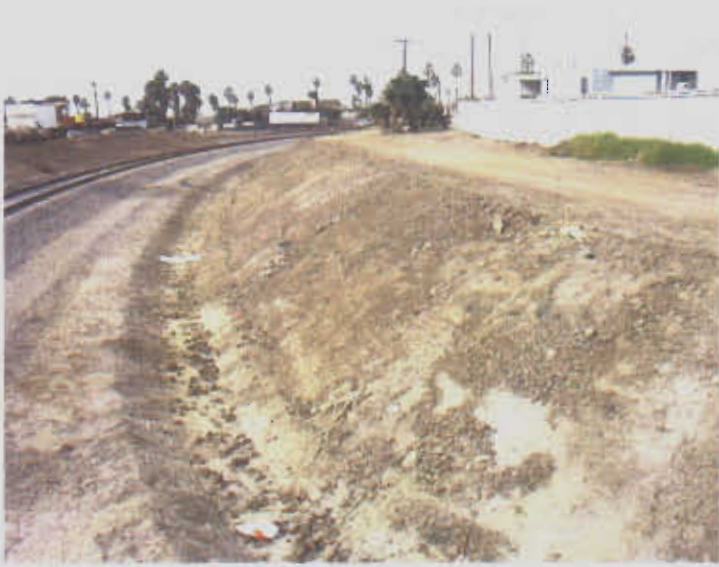
13. Exposed slopes with no erosion controls or sediment controls.

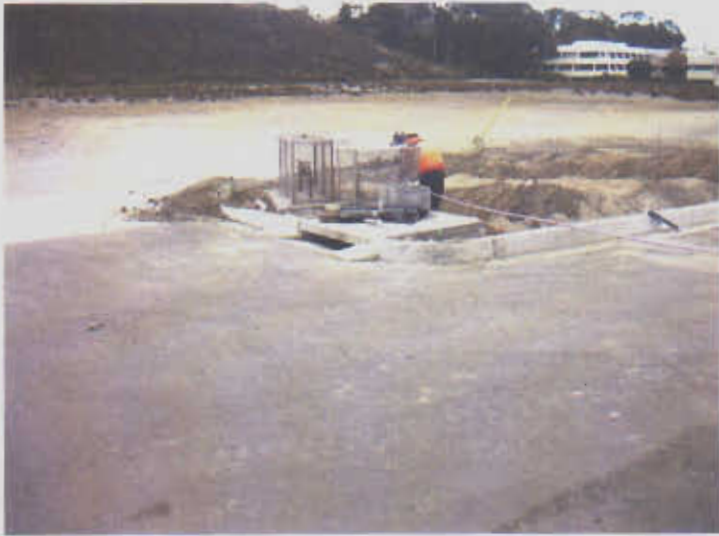
**3. Crouch Street Station in Oceanside** - This station is located near the intersection of Crouch Street and Oceanside Boulevard. Exposed dirt behind curbs lacked sediment controls while inlet protection nearby was also lacking (Photos 14 and 15). Fiber rolls near Loma Alta Creek were not trenched in (Photo 16). Slopes along the creek lacked erosion controls and sediment controls (Photos 17, 19 and 20). Cold mix (asphalt) was left out in a field without any BMPs (Photo 18).

14. Lack of sediment controls at curbs and incomplete inlet protection.

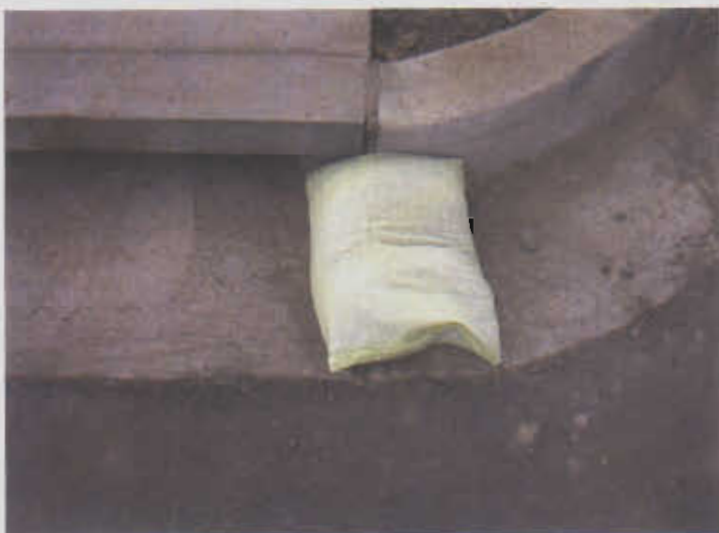
15. Inlet needs more protection.

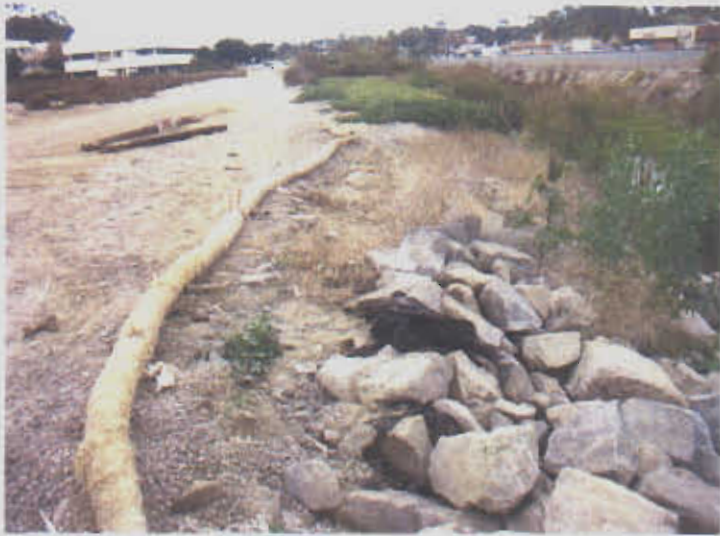
16. Fiber roll not properly  
trenched in.

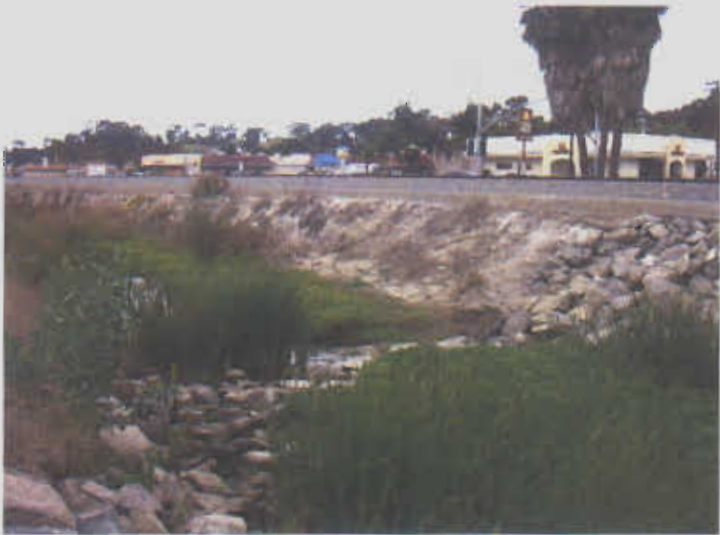
17. No erosion or sediment  
controls on slopes.

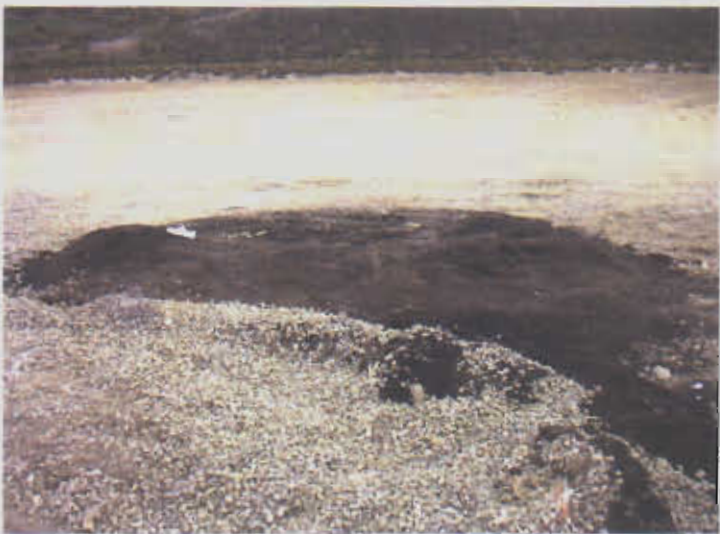
18. Cold mix stockpile without  
protections.

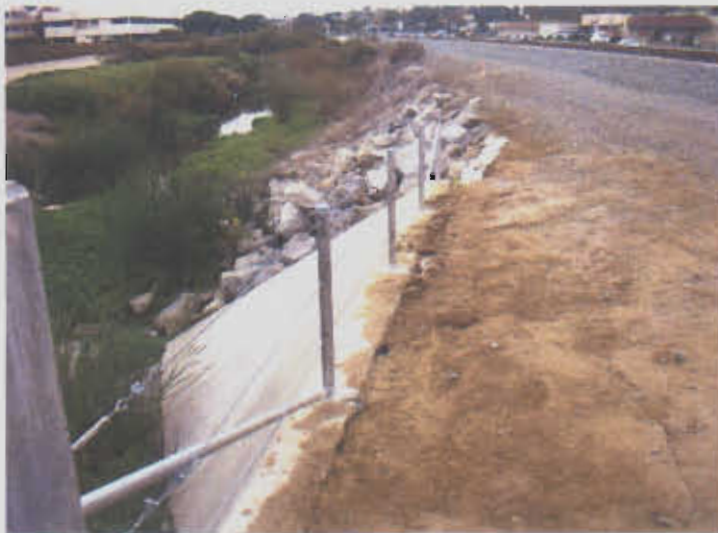
19. No erosion or sediment control along Loma Alta Creek.

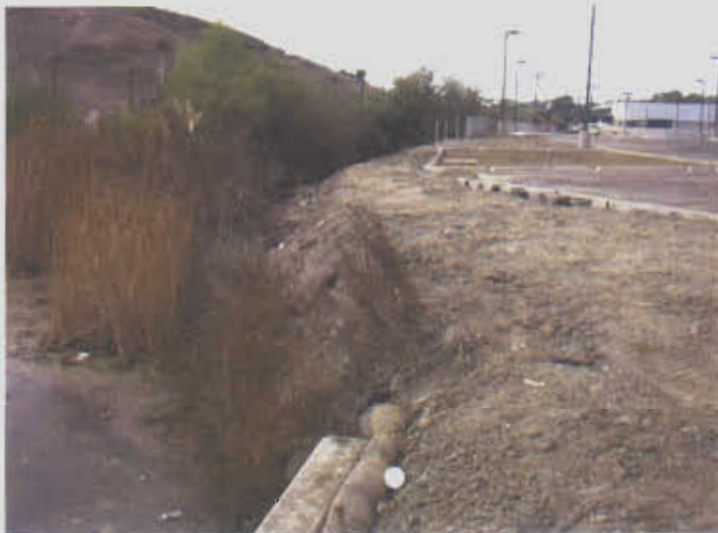
20. Lack of erosion and sediment controls for exposed soil.

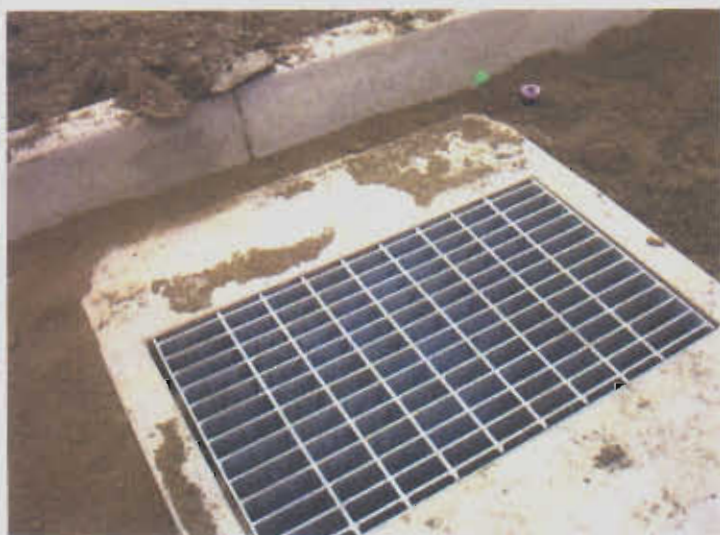
**4. El Camino Real Station in Oceanside** - This station is located at the intersection of El Camino Real and Industry Road. A storm drain inlet at the station lacked sediment controls although it was surrounded by dirt (Photo 21). Both sides of Loma Alta Creek were in serious need of both erosion and sediment controls. Bare, friable soil on generally steep slopes in this area constitute a significant erosion hazard (Photos 22 through 26).

21. No inlet protection.

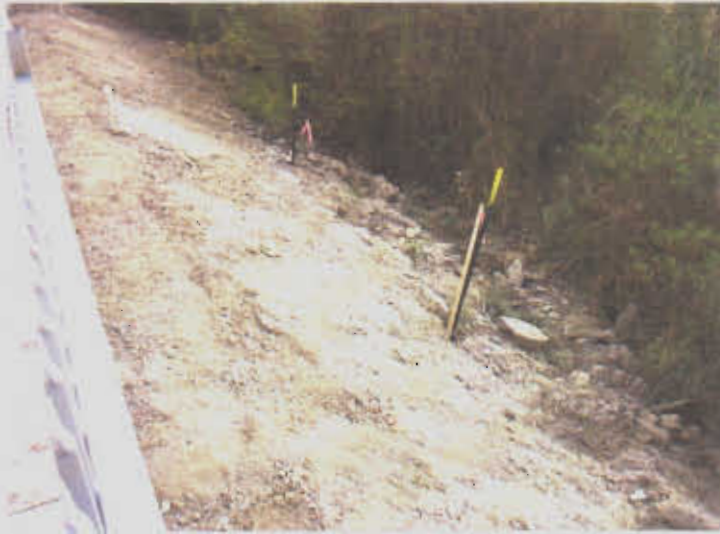
22. No erosion or sediment controls on steep slopes along Loma Alta Creek.

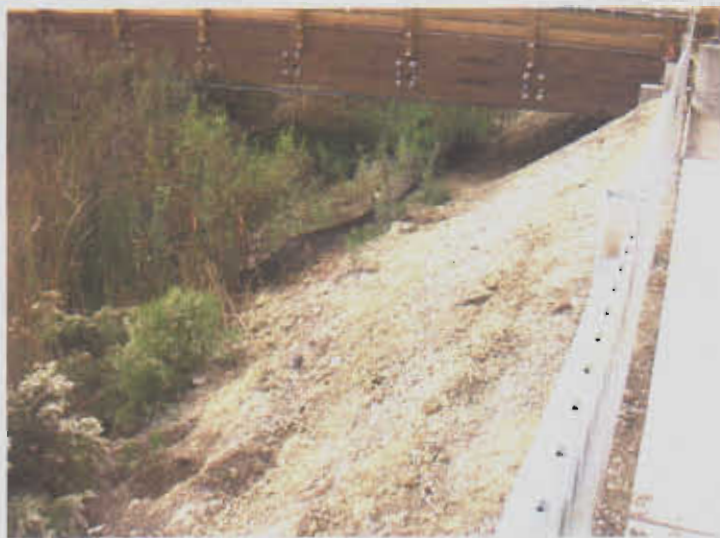
23. No erosion or sediment controls next to bridge on Loma Alta Creek.

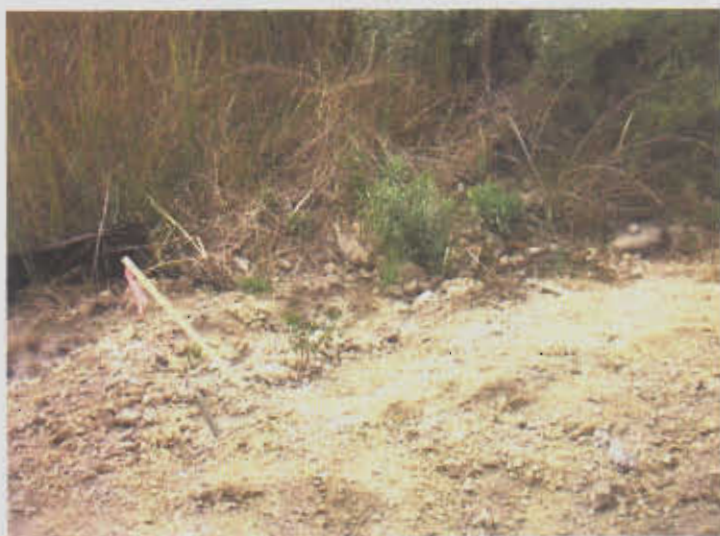
24. Lack of erosion and sediment controls. Silt fence provides incomplete sediment control because it terminates prematurely.

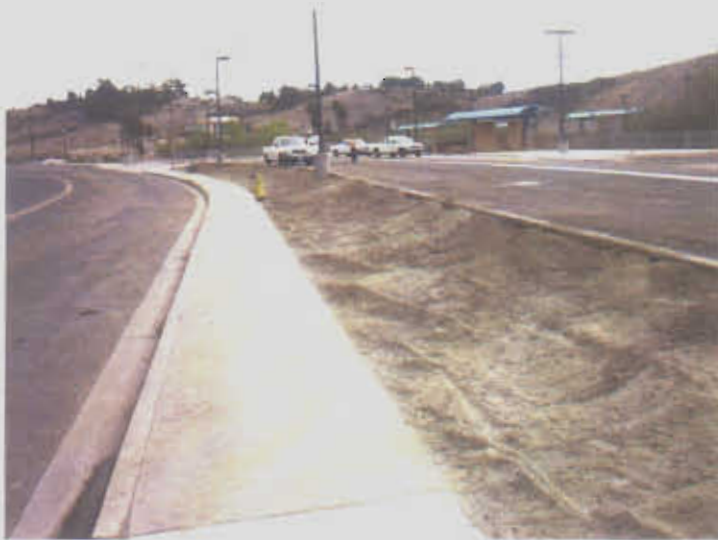
25. No erosion or sediment controls.

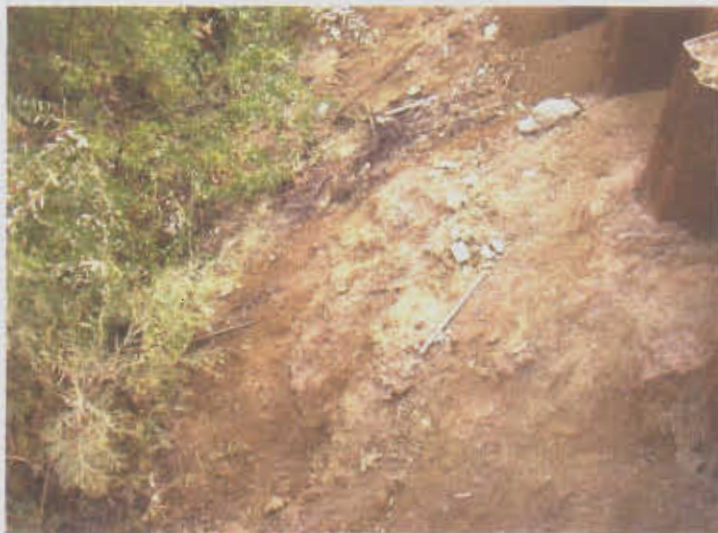
26. No erosion or sediment controls on north-facing slope next to station.

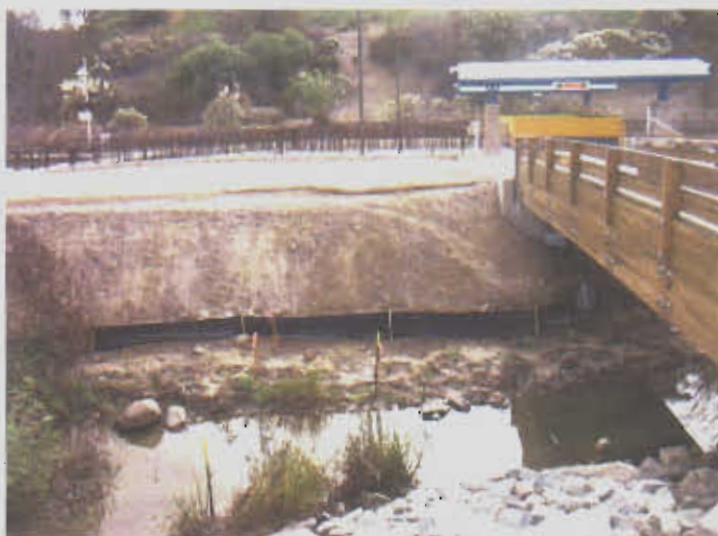
**5. Rancho Del Oro Station in Oceanside** - This station is bordered by Rancho del Oro Road to the east. Loma Alta Creek runs through the north side of the station. A pedestrian bridge is being built over the creek to access the station. A silt fence was installed in Loma Alta Creek where it will not prevent impacts to the creek (since it will only attenuate sediment that has already reached the bed of the creek) and the slopes above the creek were without erosion controls (Photo 27). Note that these violations were cited in the October 5, 2007 inspection report (and NOV No. R9-2007-0208) and still have not been corrected.

27. Silt fence improperly installed in Loma Alta Creek. No erosion controls on south-facing slope. Same violations noted in NCIV No. R9-2007-0208.

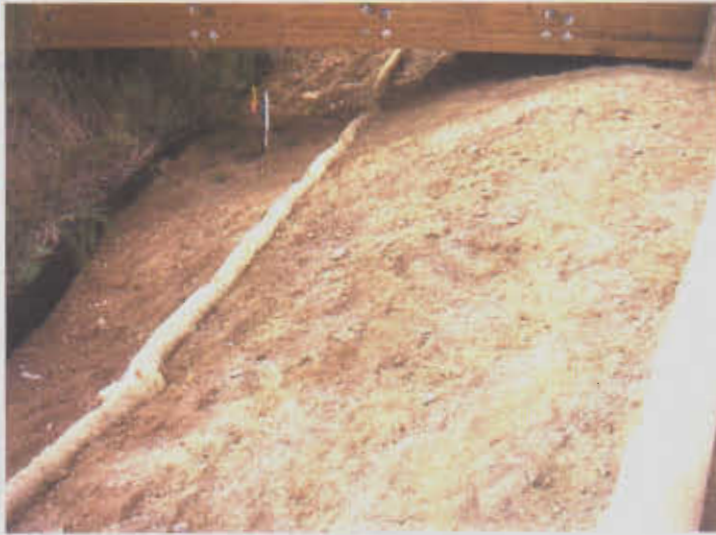
**6. College Blvd Station in Oceanside** - This station is next to Loma Alta Creek in a shopping center on the southwest corner of College Boulevard and Oceanside Boulevard. Erosion controls have not been implemented on the banks of Loma Alta Creek, even though this violation was noted in NOV No. R9-2007-0208 pursuant to the October 5, 2007 inspection (Photo 28).

28. Continued lack of erosion controls on north-facing slope – same violation noted **NOV No. R9-2007-0208**.

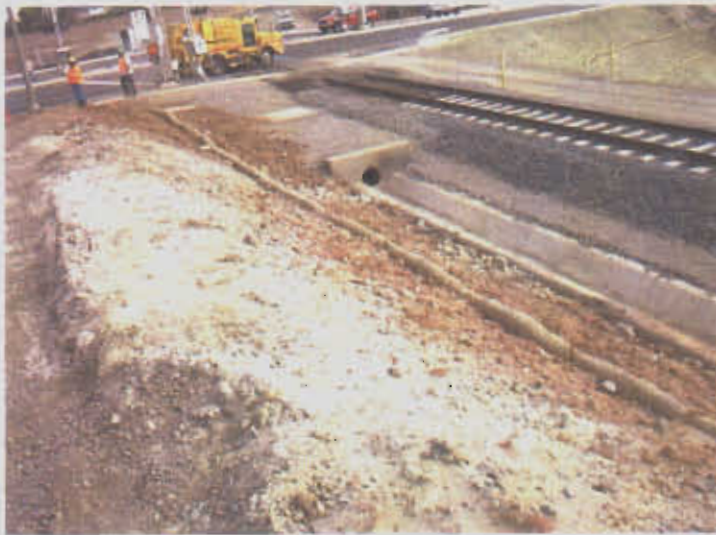
29. No erosion controls on north-facing slope.

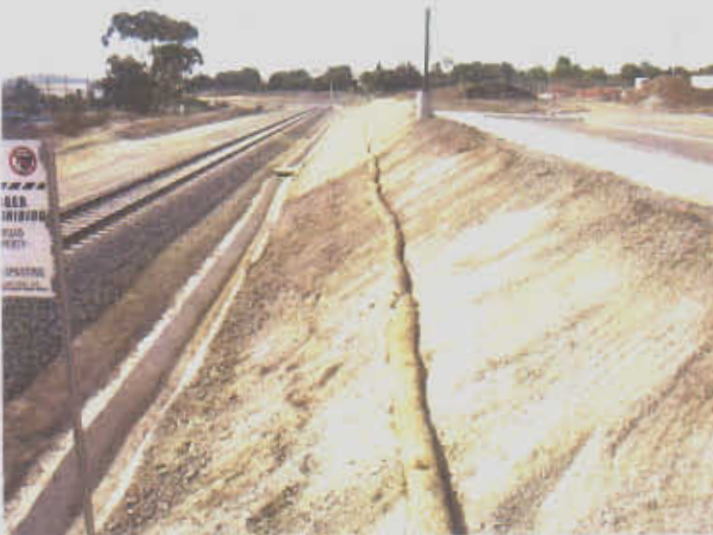
30. North-facing slope – looking to the east. Large area left without hydroseed.

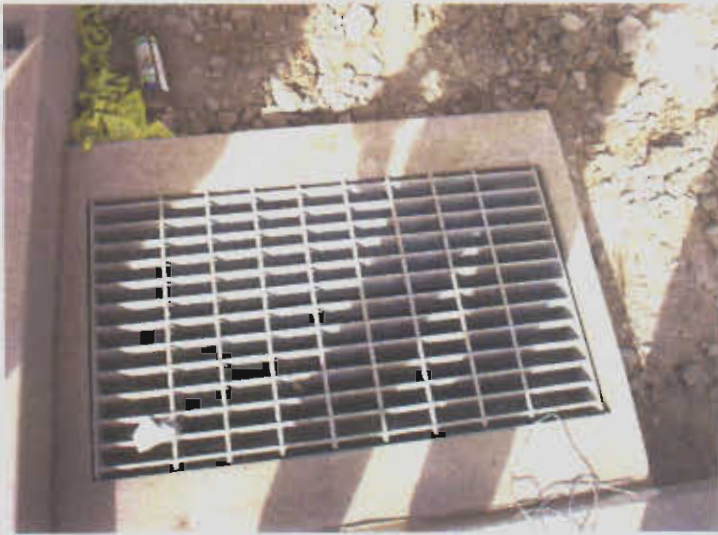
31. No inlet protection in area still under construction.

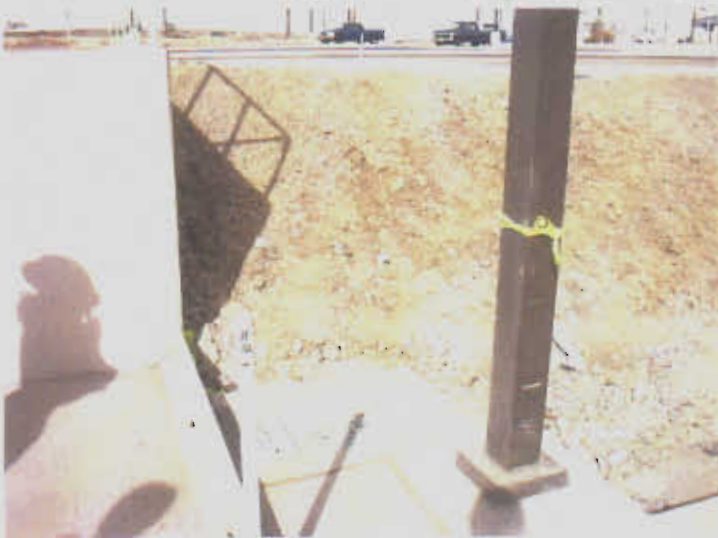
32. No sediment or erosion controls in area above storm drain inlet. No inlet protection.

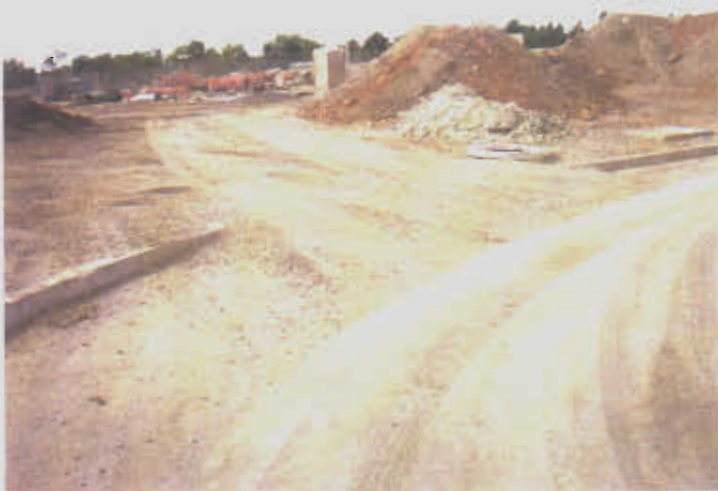
**7. Melrose Drive station in Oceanside**- This station is on the southwest corner of Melrose Drive and Oceanside Boulevard next to a convenience store. The headwaters to Loma Alta Creek flow adjacent to the south side of the tracks. Lack of erosion controls were cited in several prior NOV's. Erosion controls have still not been implemented in the area of the station (Photos 29, 30 and 32). Photo 30 shows that hydroseed was applied far to the west of the station but the application was discontinued, leaving no erosion controls (only fiber roll which is a sediment control) in the area of the station. Sections of fiber roll abut each other (do not overlap). This problem was cited in past NOV's. In addition (another problem cited in earlier NOV's) fiber rolls were not trenched in. A storm drain in the station area lacked inlet protection (Photo 31). Lack of sediment tracking controls in an area west of the parking lot was cited in the last NOV. Sediment tracking controls were still lacking in this area (Photo 33).

33. No sediment controls to prevent sediment tracking.

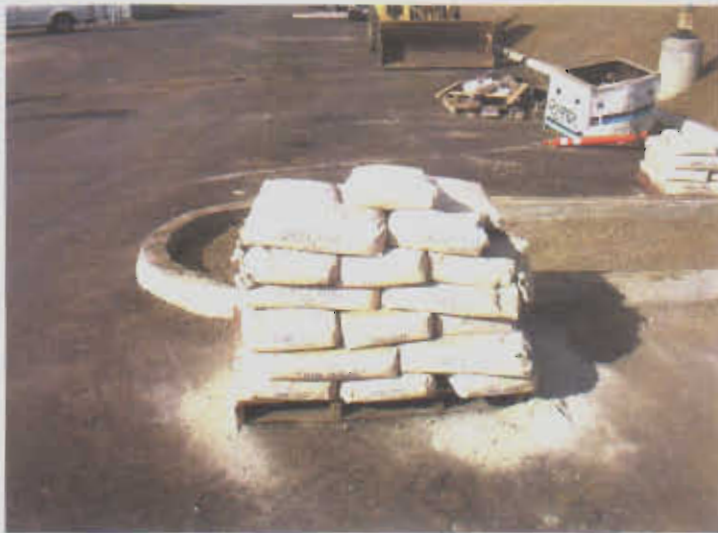
34. Cement mix spilled in parking area.

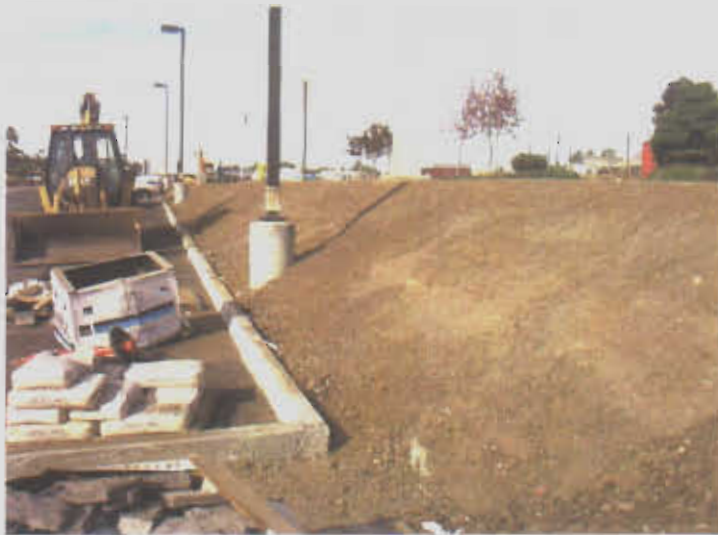
**8. Vista Transit Center in Vista.** The Vista Transit Center is located near the corner of Vista Village Drive and Santa Fe Avenue. Station construction appears to be near completion at this location, however, landscaping has not been initiated leaving large areas of exposed soil. Cement bags stored in the parking lot were leaking cement powder (Photo 34). Dirt slopes surrounding the parking lot were without erosion or sediment controls (Photos 35 and 36). An inlet in the station was well protected by gravel bags (Photo 37).

35. No sediment or erosion controls on slopes surrounding the parking lot.

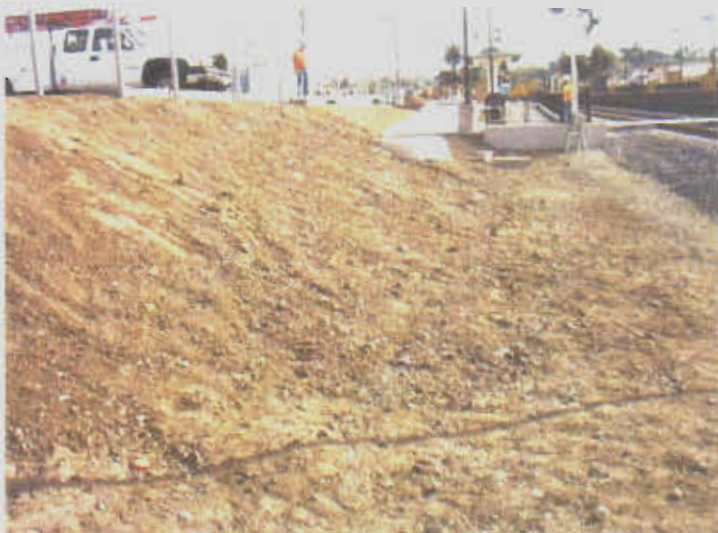
36. No sediment or erosion controls on exposed slopes.

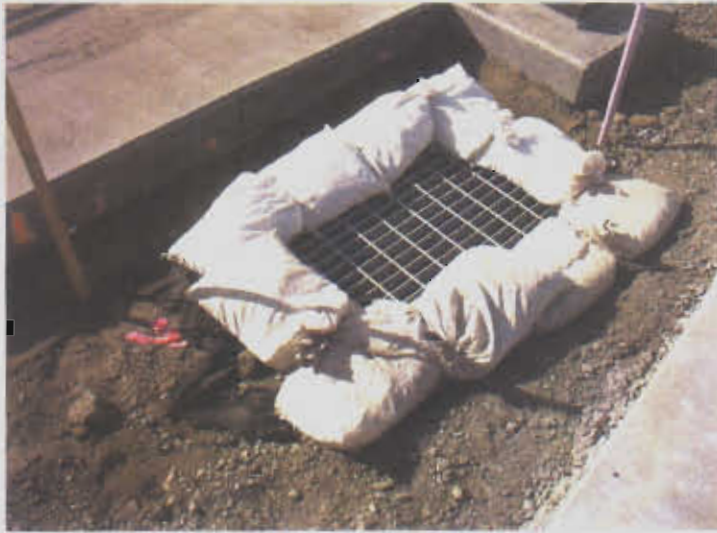
37. Properly installed gravel bags.

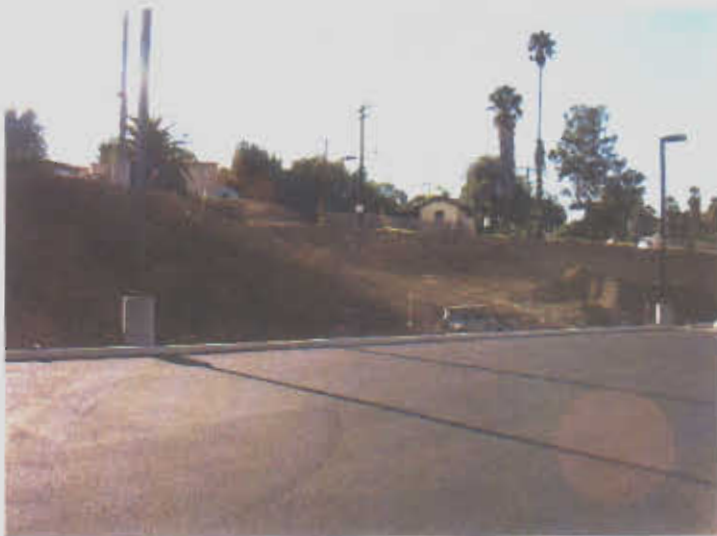
**9. Escondido Avenue Station in Vista.** This station is located at the intersection of Escondido Avenue and Phillips Street. Dirt slopes surrounding the parking lot had no erosion or sediment controls (Photo 38). Gravel bags outside a storm drain inlet were not stacked high enough to adequately protect the inlet (Photo 39). In addition, the channel leading to this inlet lacked any stabilization. An inlet in the parking lot was covered with filter fabric, but did not have sufficient sediment controls (e.g. gravel bags) to prevent clogging by sediment (Photo 40). Another storm drain inlet in the parking lot had no inlet protection whatsoever (Photo 41).

38. No erosion or sediment controls on slopes.

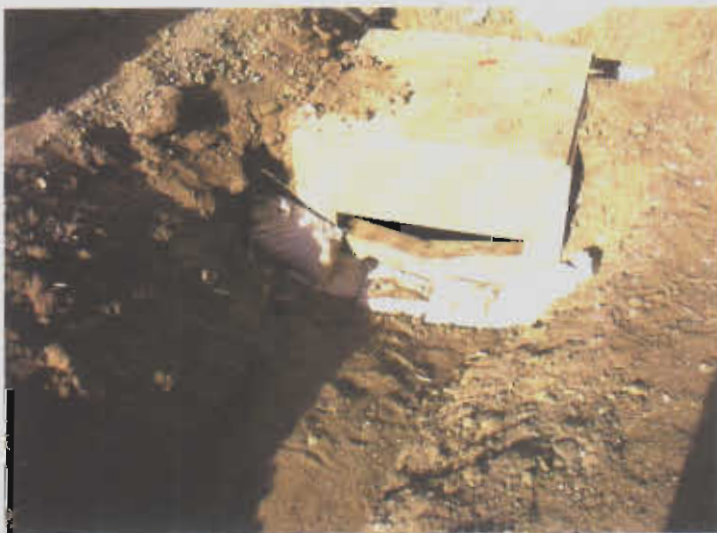
39. Gravel bags not stacked high enough to adequately protect drain inlet. No erosion protection in earthen channel.

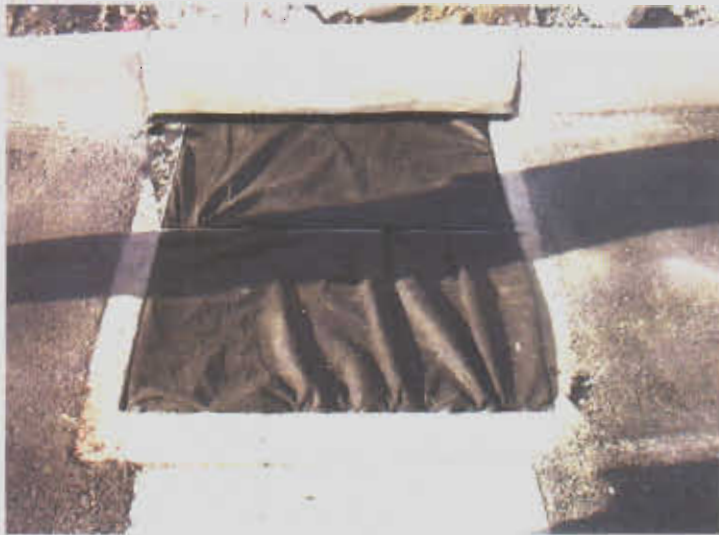
40. Filter fabric needs additional controls to prevent clogging by sediment.

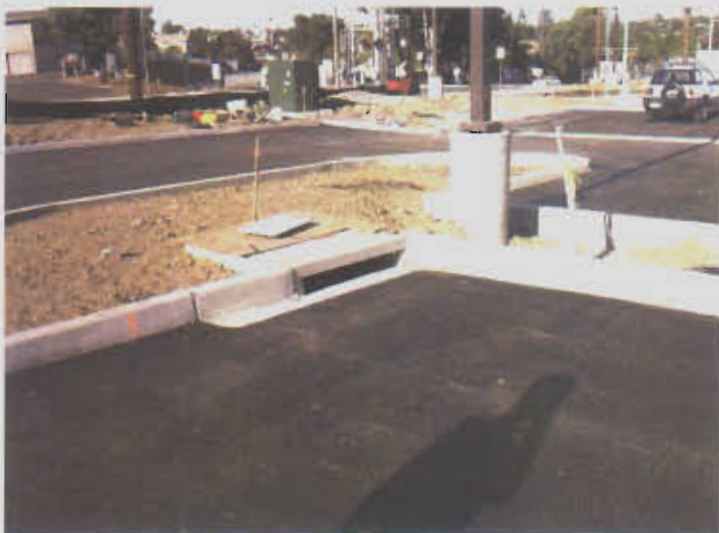
41. Storm drain lacks inlet protection. Parking lot still susceptible to sediment flows.

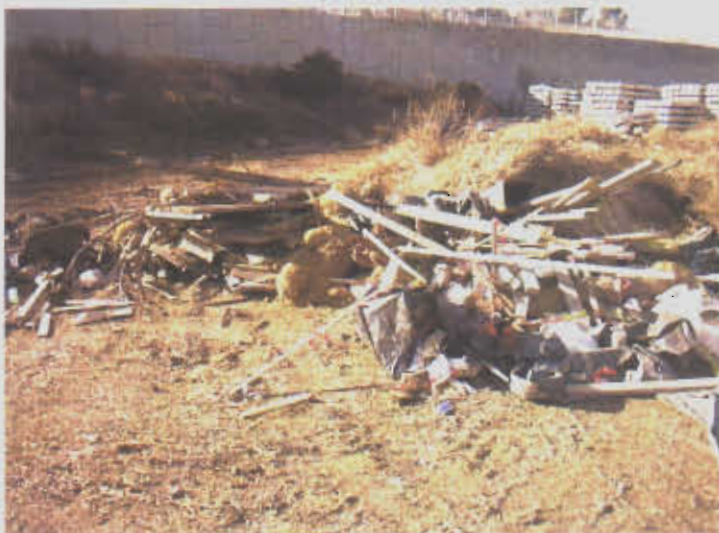
**10. Mar Vista Drive storage yard in Vista** - This location has been cited in several prior NOV's. A persistent problem has been the lack of proper coverage and containment of construction debris that is stored at this site. Once again, a large amount of debris was laying exposed in the middle of the yard (Photo 42).

42. Construction debris not properly covered or contained. Same problem noted in February of 2007.

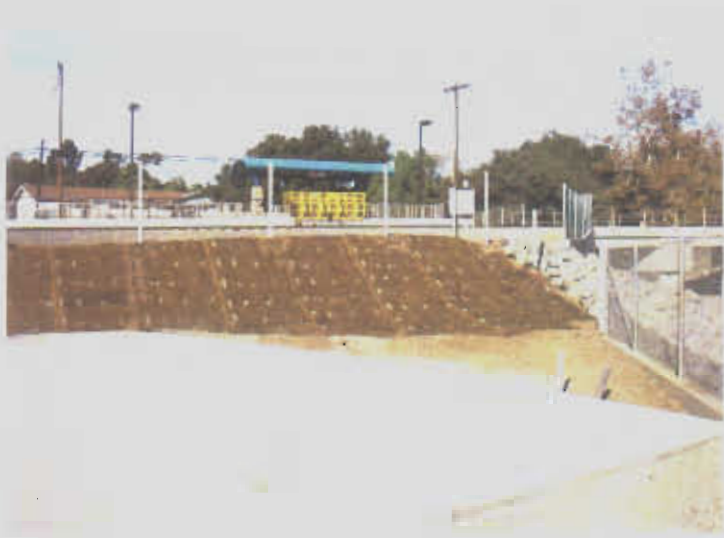
**11. Buena Creek Station in San Diego County (Unincorporated).** This station is located at the intersection of Buena Creek Road and Santa Fe Avenue. Once again, station construction is near completion, but landscape installation has not yet begun. In this case, an effective erosion control (a coconut blanket) was being employed (Photo 43).

43. Coconut blanket provides effective slope stabilization.
